Halo Versus Non-Halo

Bulletin Number **TPMB-0102 (Revision 3/4/2003)**

Topic **Forced Lube System – Clutch Housing Information**

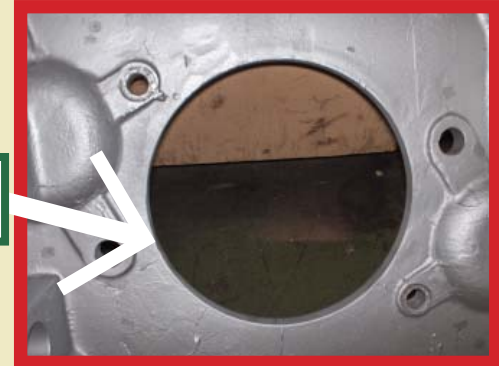
Front of Bell Housing is flat

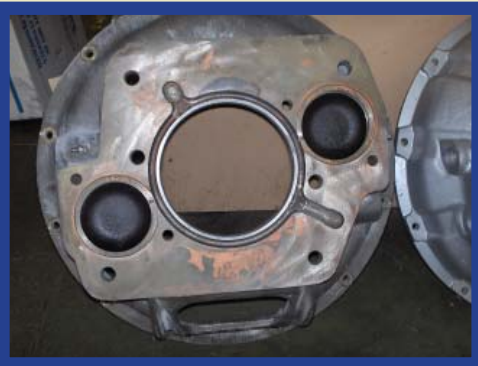
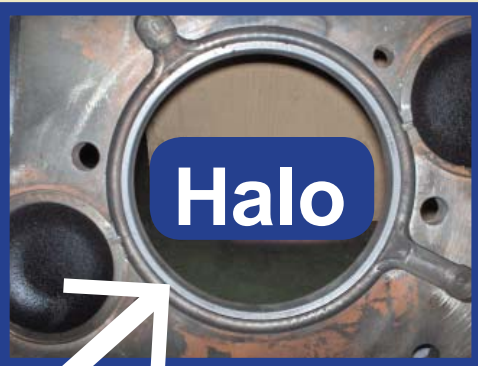
Back of Bell Housing has groove for oil tubes

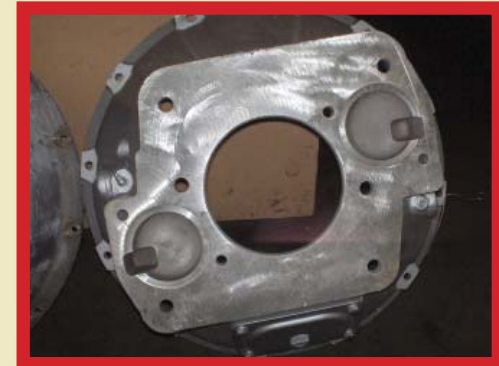
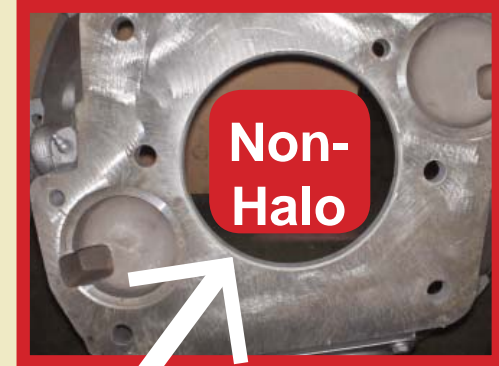
On some late transmissions, we have seen Bell Housings with a raised groove in the front, but not machined in the back for Halo System.

Back of Bell Housing is flat

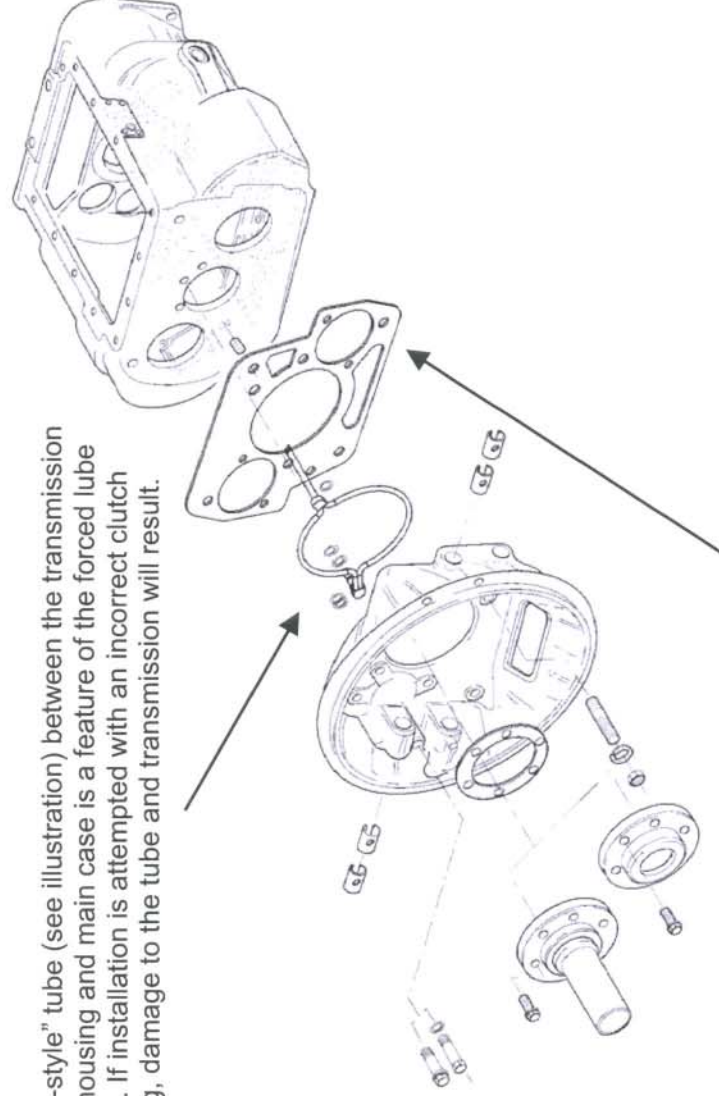
A “halo-style” tube (see illustration) between the transmission clutch housing and main case is a feature of the forced lube system. If installation is attempted with an incorrect clutch housing, damage to the tube and transmission will result.

Important note: If you are replacing a transmission that was not originally produced with the internal forced lube system, you will be unable to reuse the original clutch housing. A clutch housing that is not machined to accommodate the forced lube assembly cannot be installed on a transmission with this feature.

Note: The correct clutch housing gasket, 4304815 must be used with the forced lube system. The gasket must be in place **before** installing the lube tube assembly with the beaded side facing towards the transmission case.
